SEPTEMBER-OCTOBER 2013

Supporting a National Treasure

A one-of-a-kind scaffold system provides access for workers, materials, and other equipment to repair the earthquake-damaged Washington Monument
by Lindsay Minard

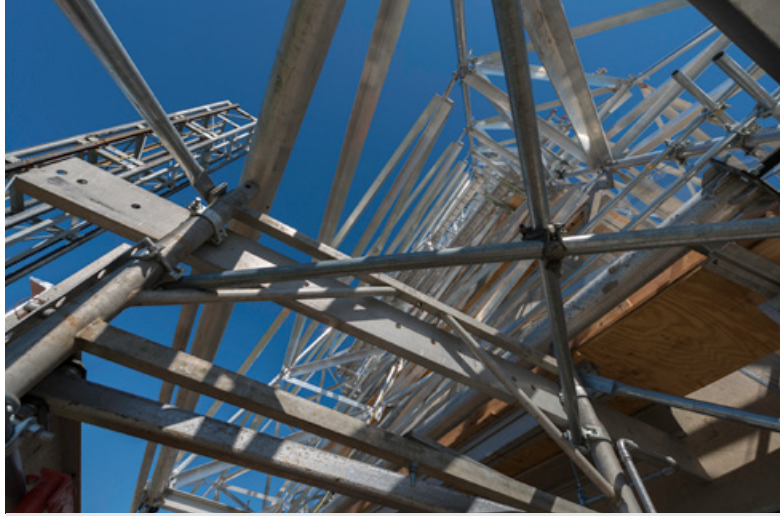
Looking upward through the scaffold at the Pyramidion shows how the crown’s structure differs from the lower structure.

“The top of this scaffold structure is crowned with a single fabricated piece that collects the truss-like members that span the 70 ft.” says Tsirigos. “The crowning structure does not rely on the monument for any lateral bracing or support and follows a 17° taper to the top of the structure.”

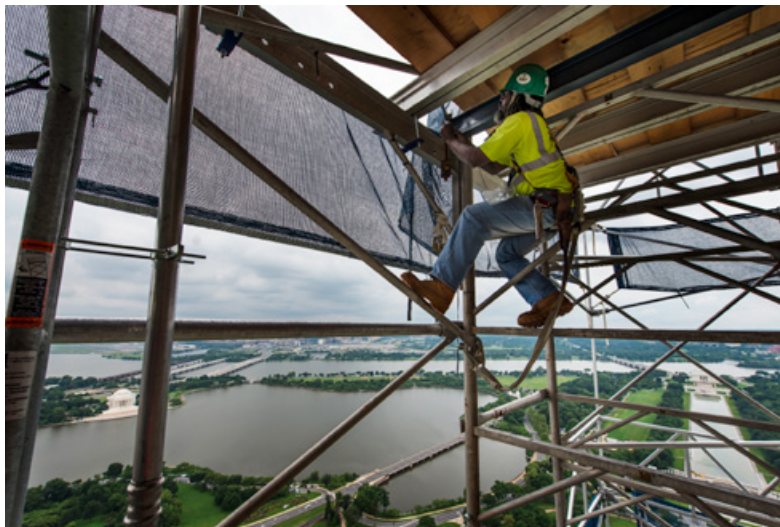
A UBS team of as little as 12 and as many as 30 met the challenge of erecting the scaffold system.

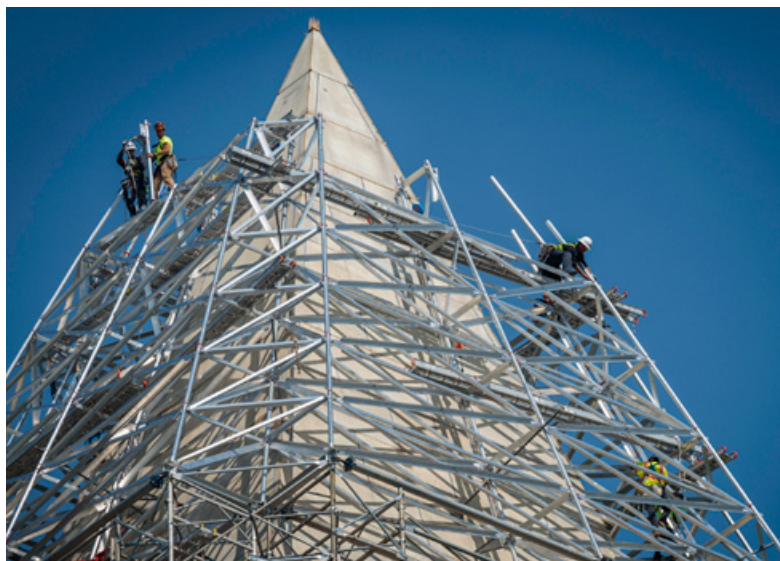
From 500 to 555 ft. a 70-ft.tall, fabricated aluminum structure crowns the structure’s Pyramidion.

Once the scaffold reached the 500-ft. elevation, or the base of the Pyramidion, UBS took on topping off the monument—a feat accomplished with an additional 70-ft. tall, fabricated aluminum structure that truly is free-standing.

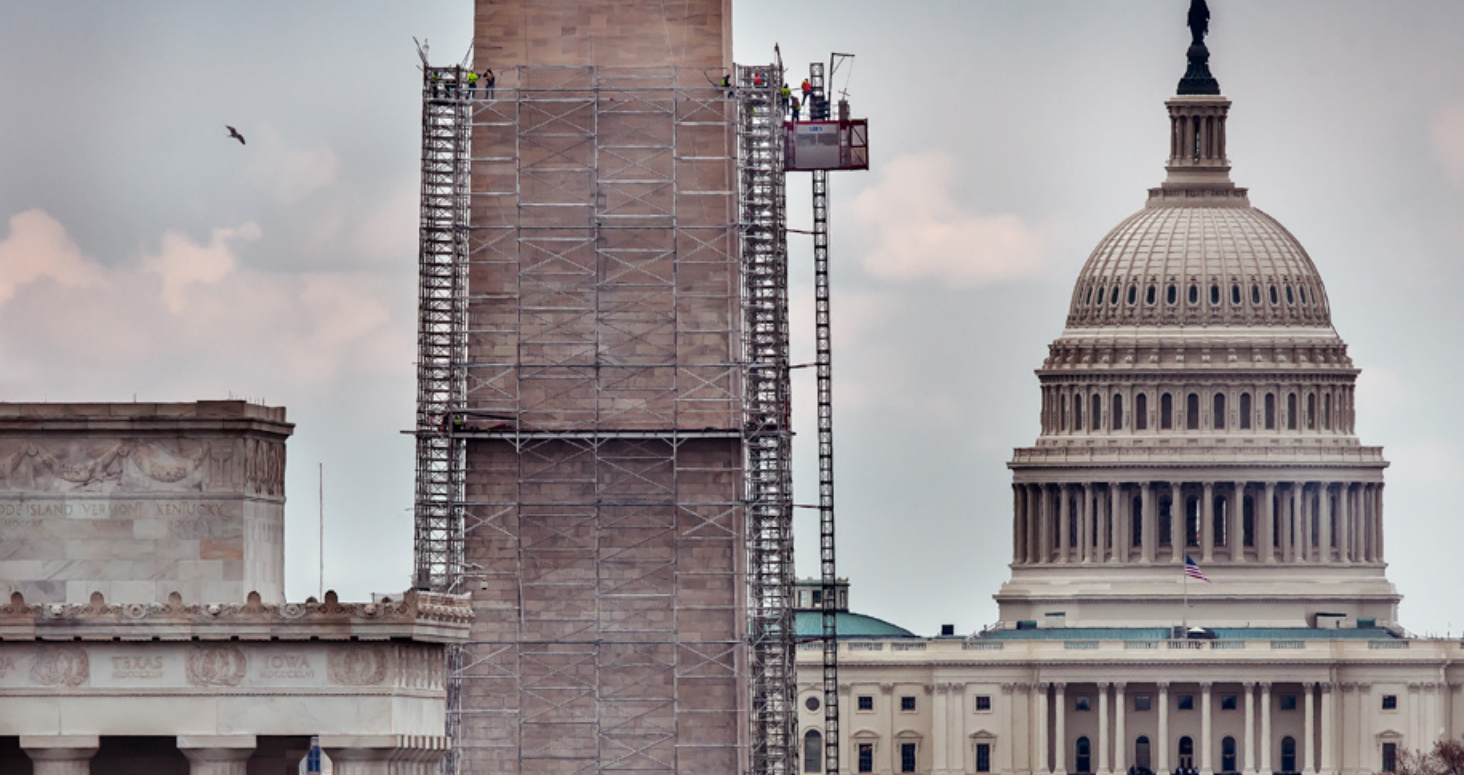
The 2013 scaffold system has the hoist, which is anchored to the scaffold, outboard of the system. In 1998 the hoist was inside the scaffold, making it difficult to access the south face.

A significant difference between the 1998 scaffolding system, and today’s is the location of the hoist that was inside the scaffold system the first go round; this presented challenges for accessing the south face of the structure. “Today, the hoist is outboard of the scaffolding to allow for uncluttered access to all faces of the monument,” says Terry.

Materials and workers access five composite decks set at 100-ft. intervals from zero elevation all the way to the base of the Pyramidion (500-ft. elevation) on a 6,000-lb. rated personnel and material hoist that like the scaffold, tapers in 1° from zero to 500 ft.—again, with no mechanical anchors used.

“What is unique about the hoist are its ties that allow it to be anchored to the scaffold itself at the 100-ft. deck levels,” explains Tsirigos. “The scaffold braces are beefed up at those intervals to accommodate the special hoist ties, as the hoist relies solely on the scaffold as a support structure.”

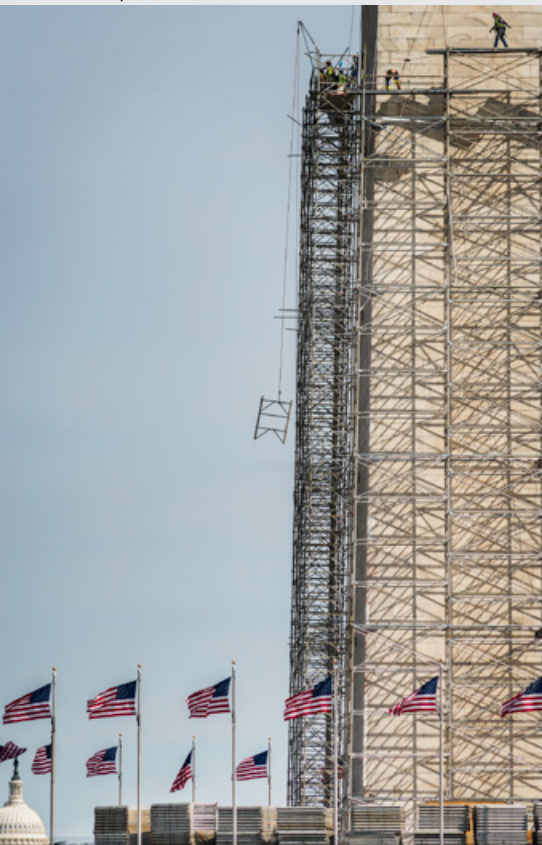
The aluminum scaffold system is designed to withstand a million pounds of ice.

The tweaked design accommodates increased criteria for the code-mandated wind speed and ice loading capacity.

“What drove the design of the system in 1998 and today, from an engineering standpoint, was wind and extreme weather conditions,” says Tsigos. “Ice accumulation on this engineered structure has the same potential effect as it does on power lines or trees. The UBS structure has a design load in excess of a million pounds to accommodate the potential accumulation of ice on the structure.”

This scaffold system capable of taking on a million pounds of ice is constructed of “extra” heavy-duty aluminum, and has an extraordinary high load carrying capacity while maintaining the inherent lightness of the material. Additionally, the aluminum does not rust and stain a building as other more conventional systems might—a definite no-no in this situation.

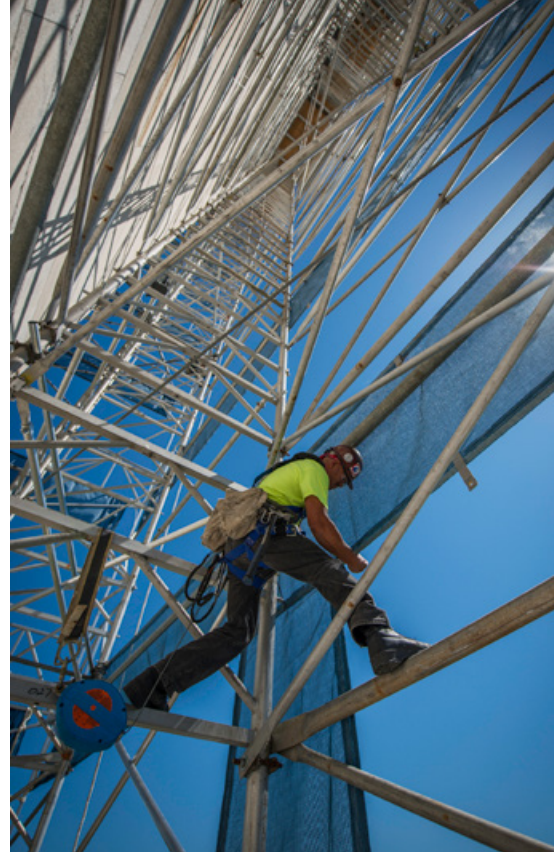
The scaffold has a 1° taper created by tilting it inward towards the monument and its end tower panels towards the center.

The system did employ some standard parts and pieces; however, the girths and braces of the main scaffold system were specially designed to allow the structure to follow the 1° taper of the monument from zero to 500 ft.—with no mechanical anchors, which are strictly prohibited by the NPS.

In order to make the 1° taper possible, the scaffold was tilted inward towards the monument, and its end tower panels towards the center, creating a true 1° tapered corner. To achieve the tilt, girths and braces of varying lengths were used on the corner tower panels.

“Because these corner tower panels were tilted to create the corner, they also required special shim stacks to allow the panels to maintain the same elevation as the adjacent tower panels during installation,” continues Tsirigos.

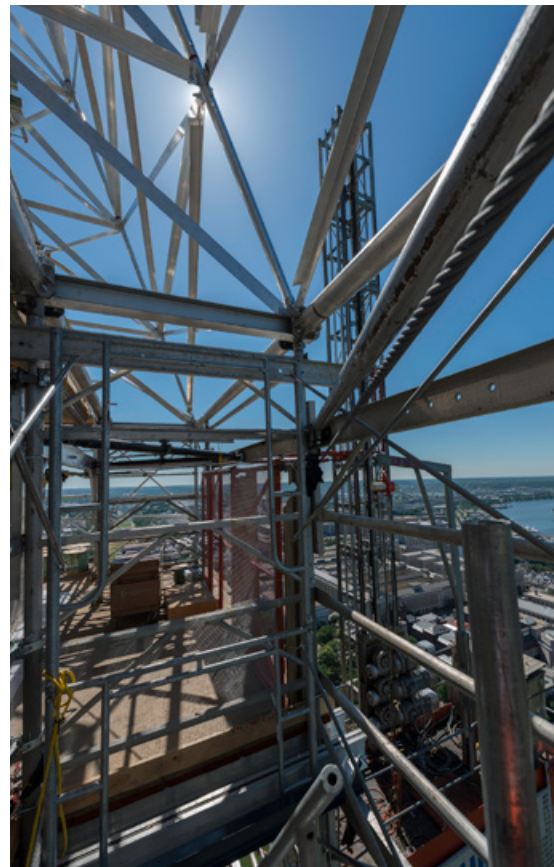
At the base of the Pyramidion the angle of the scaffold tilts, going from a 1° to 17° taper all the way to the top of the structure.

The Washington Monument’s top hat of sorts features 72 lifts, each with a quarter inch shim stack that ensured the frames were flush to one another once they reached the peak.

To visualize, take two chopsticks—one sitting vertical, the other tapered in 5°. “Even though the chopsticks are both 12 in. long, the tapered one travels a shorter distance. So every time we put another lift on we have to put a shim stack because with every lift we’re losing a fraction of an inch,” portrays Tsirigos.

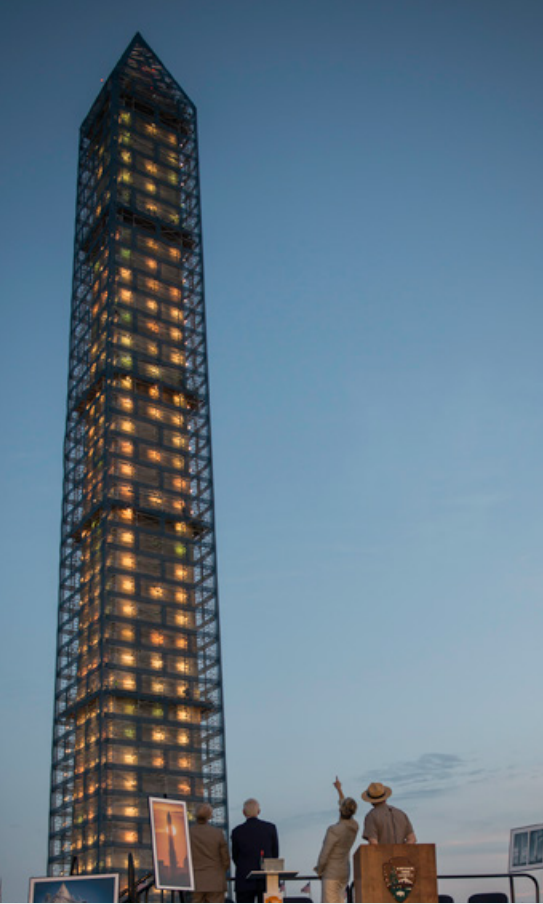
The scaffold, wrapped in decorative scrim and lights, was lit July 9, 2013.

By May 2013, the UBS team completed the scaffolding by crowning the Pyramidion—an engineering feat that was highlighted July 9, 2013, when the landmark, wrapped in decorative scrim and lights, lit up the night—making the monument, even under repair, certainly still a sight to see.
